Surface Mechanical Effects of Wildfires on Rocks in Climbing Areas

Pablo Yeste-Lizán ^{1,*}

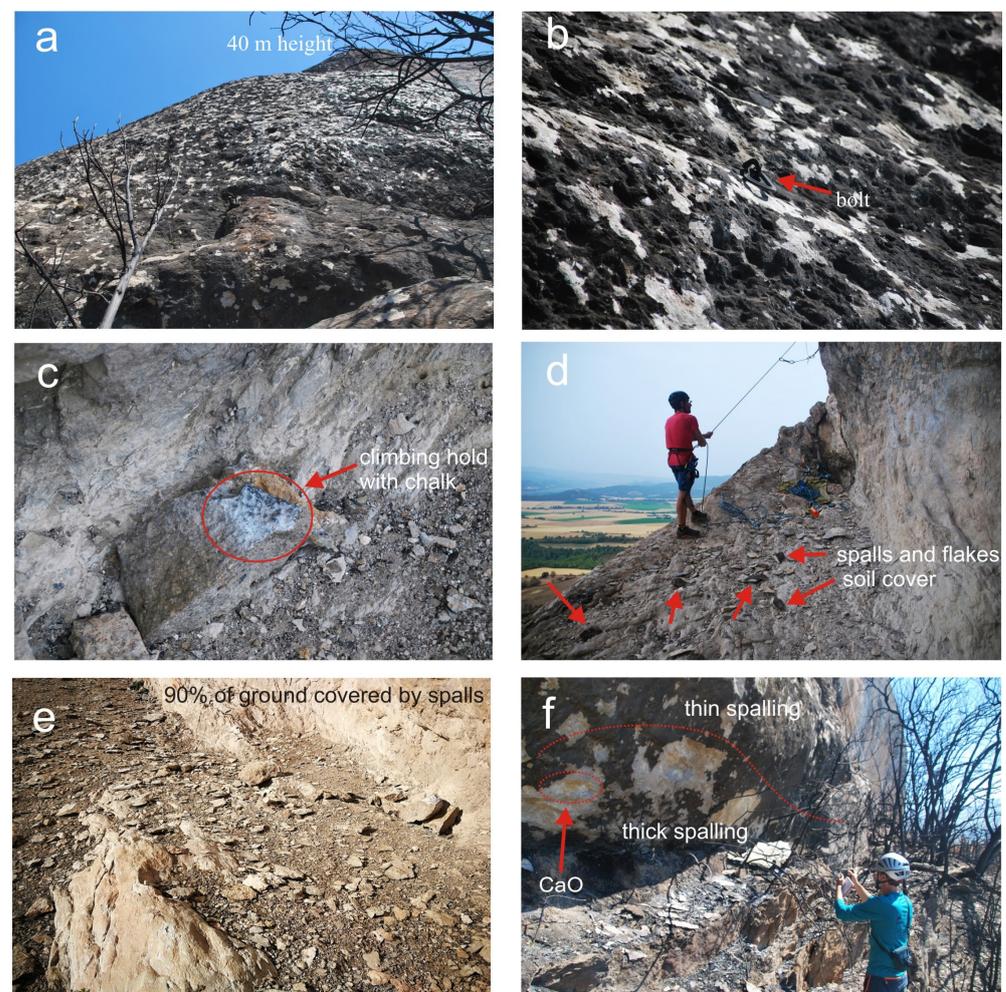
The wildfire effect observed on the climbing wall is the fall-out of thin slabs, arranged as great patches of metric size in some sectors of the wall. Spall scars show clean and fresh areas, easily observable and different from the dark burned areas without detached slabs. The thickness of the spalling oscillates between 2 and 20 mm, with 5 mm on average (Table 3). The spall size ranges from 5×10^{-3} to more than 0.5 m^2 . The lower part of the climbing wall has been affected by the wildfire, where it is impossible to identify the spall sizes. The effect of the wildfire is lower in the upper part of the climbing routes (Table 4).

Figure 7. Visible rock surface decay features in Oliana as a result of the fire: (a) flaking and spalling on the left side of the climbing crag; (b) extensive flaking affecting an anchor; (c) large rockfall from a climbing route (notice that the rock still preserves the climbing chalk); (d) climbing area covered by spalled flakes; (e) ground of climbing area is 90% covered by spalls (photograph: Toni Mas); (f) limit of thick and thin spalling due to prolonged heat in the lower part provided by adjacent burned bushes.

Regarding the size of the detached spalls by wildfire in the Oliana climbing wall, we measured blocks of 1.8 m long, 0.15 m thick, and about 2 m² in area. These fractured blocks are more abundant close to the ground, although they can be observed up to 3 m high in the wall. Moreover, previous fractures and weakness planes could favor the breaking of these blocks. In the most affected areas, spalls covering 90% of the soil were observed (Figure 7e).

The work carried out has allowed the identification of some geological risks, mainly due to rockfalls of flakes and blocks from the walls most affected by the fire. Prior to this publication, we suggested to local climbing communities, social networks, and official mountain federations some general safety recommendations for climbers visiting walls affected by fires similar to those discussed in this paper: (1) the first visitors to affected areas should alert the climbing community to the possible risks of transit and climbing; (2) wear a helmet at all times when approaching the walls and avoid walking close to the base of the walls; (3) clean the entire wall, starting from the top, removing all loose rock fragments that have not yet fallen; (4) test the anchors of the routes affected by the fires; and (5) allow several rain events to pass that favor natural rockfall.

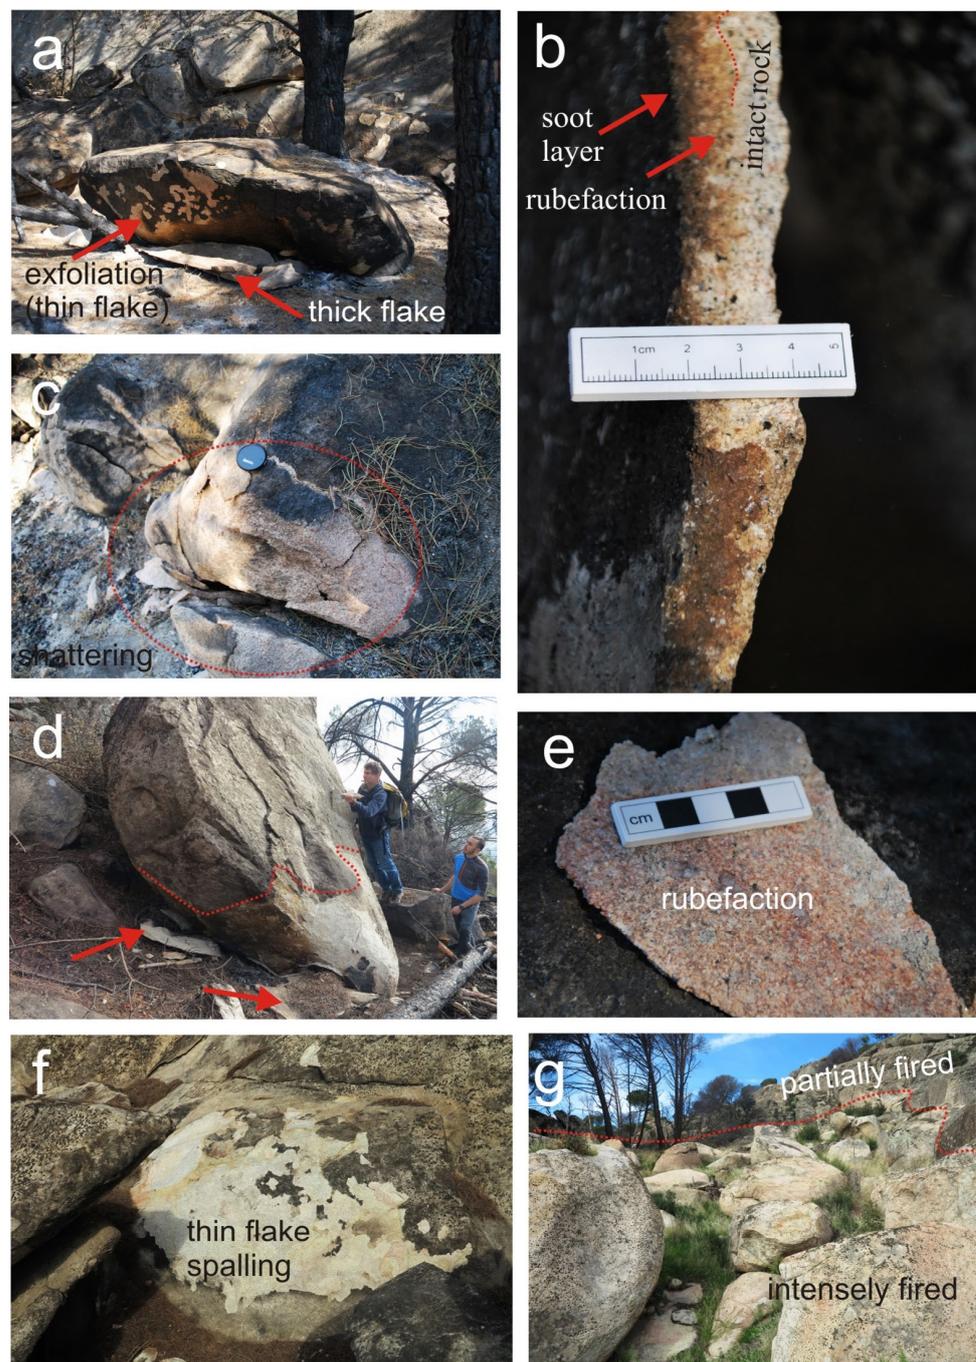
In Cadalso de los Vidrios, the effects of the wildfire affecting the granite rock surface depend on the persistence and temperature of the wildfire. In general, the effects of the wildfire were limited (Table 4), and the bottom 2–3 m of the walls were the most affected parts of the climbing routes. The main effect observed was detached rock spalling, with the spall thickness ranging from a few millimeters to a few centimeters (Table 3). The spalled areas range between 20 cm² and 0.5 m². The spalled areas are easily visible due to the sharp color change between the discoloration (either reddened or blackened) of the non-spalled rock surface and the lighter fresh-rock color of the spalled areas. Regarding the total affected climbing area in Cadalso, the east part is the most affected area, showing up to 30% of the surface of detached spalling at the bottom part of the climbing wall (Table 4). The top parts of the wall show a much smaller surface of detached spalling.

Another important effect of the wildfire is the formation of cracks in granite blocks (Figure 8), constituting a risk for climbing. These cracks can reach 1.5 m long and 1 m deep from the bottom of the granite rock. Subsets of subparallel fractures appear in areas where the wildfire reached the maximum temperature. Reddening is the result of thermal oxidation from around 300 °C, while spalling and cracking may be due to thermal shock during either the fire or its extinction. Surface temperatures above α to β quartz transition (573 °C) increase the chance of granular disaggregation instead of spalling [1,5,7].

Figure 8. Visible rock surface decay features in the Cadalso de los Vidrios site as a result of the fire: (a) flaking of blackened surface and thick spalling at the bottom part of a boulder, possibly generated by thermal shock during aerial firefighting; (b) spall showing the surface black soot layer penetrating and clogging the fire-induced surface cracks, an intermediate thermally reddened portion, and seemingly unaffected rock; (c) completely shattered boulder as a consequence of intense thermal shock; (d) boulder showing a 1 m thick shattered portion at the bottom and spalling at the top, possibly due to prolonged heating caused by the burning of an adjacent log that appears to be completely burned; (e) reddened spall due to thermal oxidation of iron-rich micas; (f) boulder with extensive detached scaling and spalling, where a new “fresh” surface appears in the detached areas; (g) the clearer “fresh” surface formed after spalling is more abundant in areas that were totally covered by fire. Blackened surfaces of soot deposits appear in the area only partially affected by fire.

In Cadalso, the most intense damage, expressed as severe reddening and spalling, appears in boulders on the ground surrounded by vegetation, especially logs, in line with the findings of [46] and a densely burned forest mass (Figure 8). These boulders have been subject to prolonged high-temperature wood combustion [47]. The distribution and thickness of the detached spalling is consistent with data presented by previous research in

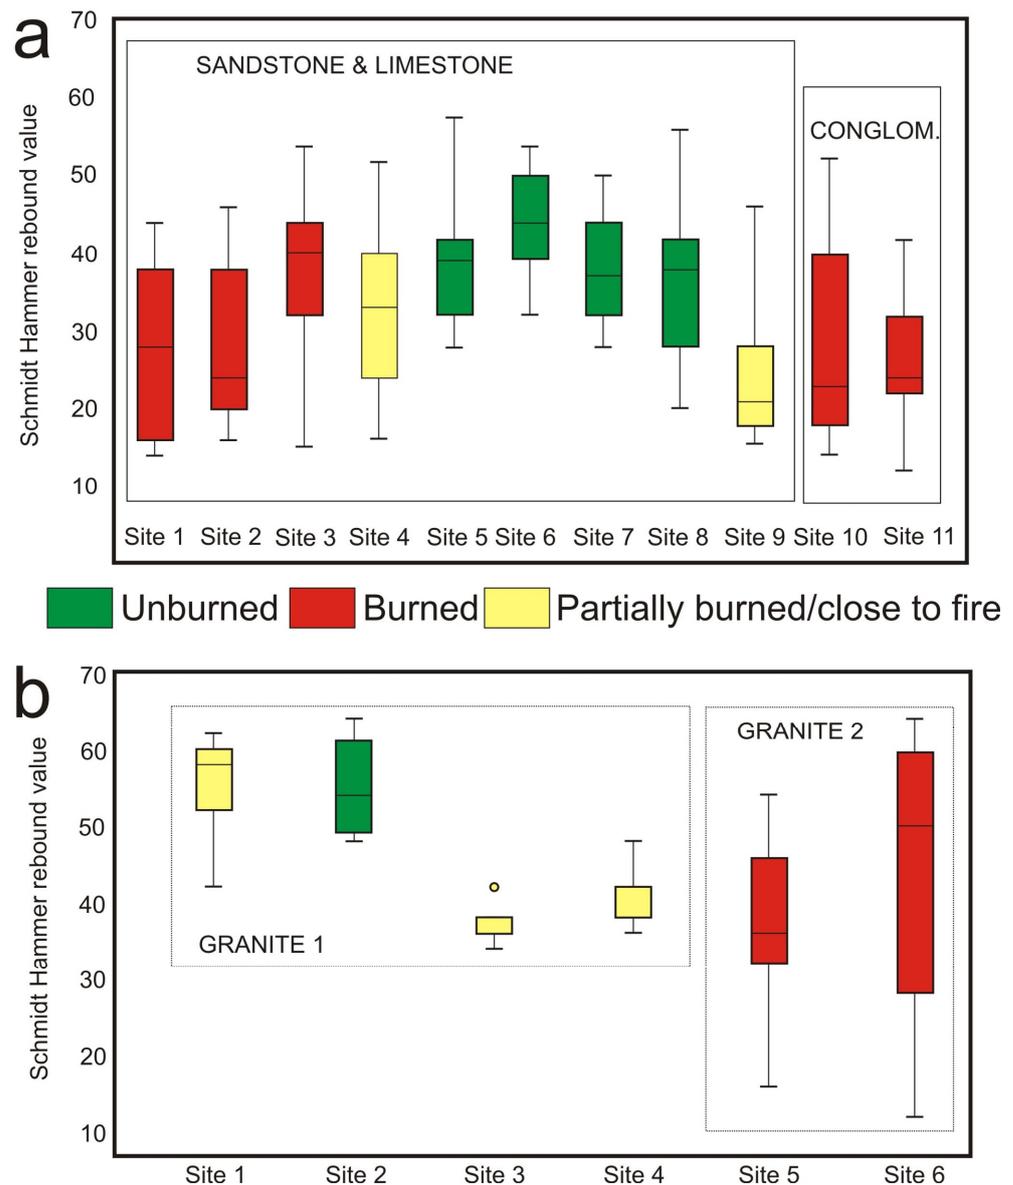
The Schmidt Hammer (SH) rebound numbers from the random grid at the bottom of both climbing areas show a clear relationship between the decrease in the rebound value and the observed mechanical damage features. The results from Oliana reinforce the idea of the increase in mechanical damage in the burned areas (Figure 9a) and also an increase in variability. The latter could be related to higher SH values measured in spalled areas in contrast with lower values in damaged areas not spalled during the fieldwork measurements.

There are two types of granite in Cadalso de los Vidrios, as seen in Figure 4b, each of them with different mechanical properties. Therefore, the results of these two granites cannot be compared with each other. Figure 9b shows the SH results for each of these granites. In the crags located in Granite 1 (corresponding to Unit 1 in Figure 4b), the highest SH values correspond to areas that do not show any feature resulting from fire (displayed with a green color), while the partially burned crags (yellow color) decrease the range of values. The two main crags located in Granite 2 (see Figure 4b, Unit 2) have been burned (red color), and the figure shows a wide range in the SH results, with more variability.

Figure 9. Schmidt Hammer (SH) values of the two studied areas: (a) Oliana with a clear variation of rebound values between sites visibly affected and non-affected by fire; (b) Cadalso de los Vidrios with two different granites along the various crags.

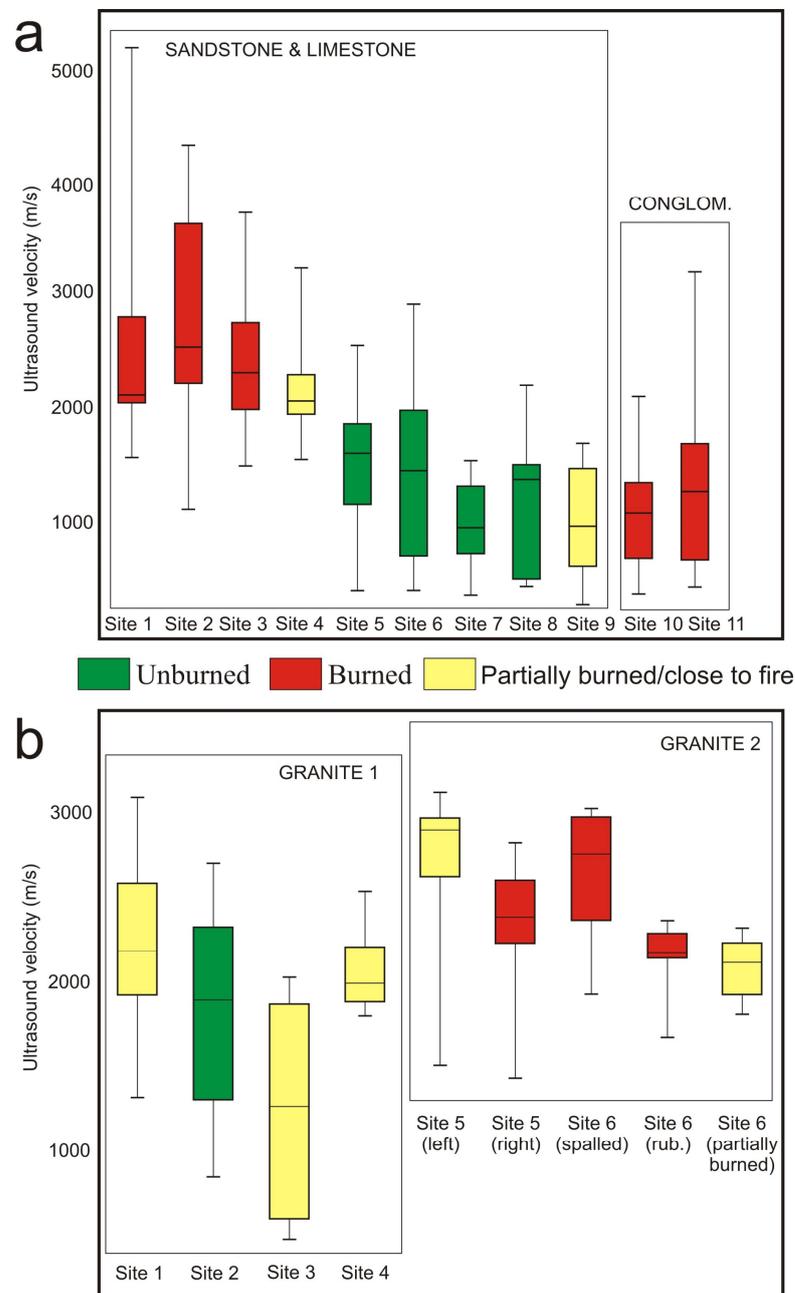
Figure 10 shows the UPV values for the random grid measurements obtained at the bottom of both climbing sites. Figure 10a shows the results displayed as a boxplot for the different climbing routes in the Oliana area. They are similar along the main wall, with the higher average values on the left side, which corresponds to the area with more visible effects caused by the fire, particularly blackened, soot-covered surfaces.

Figure 10b shows the results in the Cadalso de los Vidrios area. As mentioned for the SH values, the climbing walls occur in two types of granite; thus, the values are only comparable within each type of granite. These results do not show a clear relationship between those obtained in areas that were not affected and those that were either partially or totally affected by the fire. The comparison between the boxplots lacks statistical relevance (22.5% probability in Granite 1 and 5.6% in Granite 2 of relevant differences between data sets for a t-Student two-tailed test).

Figure 10. Ultrasound pulse velocity of the two studied areas: (a) Oliana across the entire climbing wall; (b) Cadalso de los Vidrios with two different granites along the various crags.

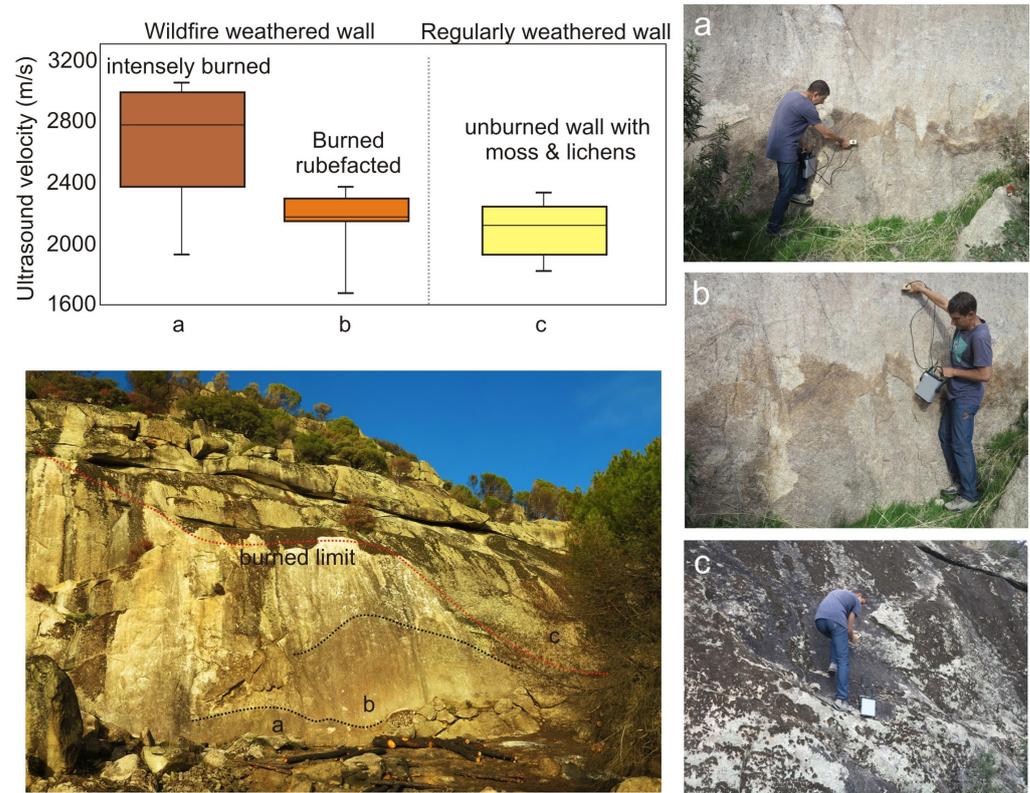
The large data dispersion and the lack of significant differences between the routes is not surprising, as fire dynamics, temperature, and fumes distribution are extremely complex and their effects may vary in different routes. Therefore, to assess the differences between areas with visible damage generated by fires, we chose a site in Cadalso de los Vidrios where a noticeable limit between different areas was identified (Figure 11). The bottom part of the wall up to 1.5 m high displays blackening due to soot cover and detached spalling (Zone a). Above this, a reddened area appears up to 5-6m height (Zone b). Close

by, on the right-hand side, is an area where preserved lichens and moss show clearly that it was not affected by the wildfire (Zone c).

The boxplot display of UPV in Figure 11 does not show highly relevant differences between “fresh” (Zone a) and reddened (Zone b) areas with 61.8 % probability of significant differences between data sets for a t-Student two-tailed test. UPV shows a significant increase in Zone c because of the combination of two effects generated by fire: detachment of spalling, which reveals new surfaces that were not affected by cracking during the fire event, and pore clogging due to the penetration of soot and fumes within the surface cracks.

Figure 11. Detailed UPV values in the Cadalso de los Vidrios climbing wall along two areas with different degrees of fire damage: (a,b) wildfire weathering. (a) Intensely burned area with a soot deposit and detached spalling at the bottom part of the wall; (b) reddened area, which occurs above one meter in height; (c) area on the right side of the wall with preserved lichens and moss, indicating that it was not affected by the fire.

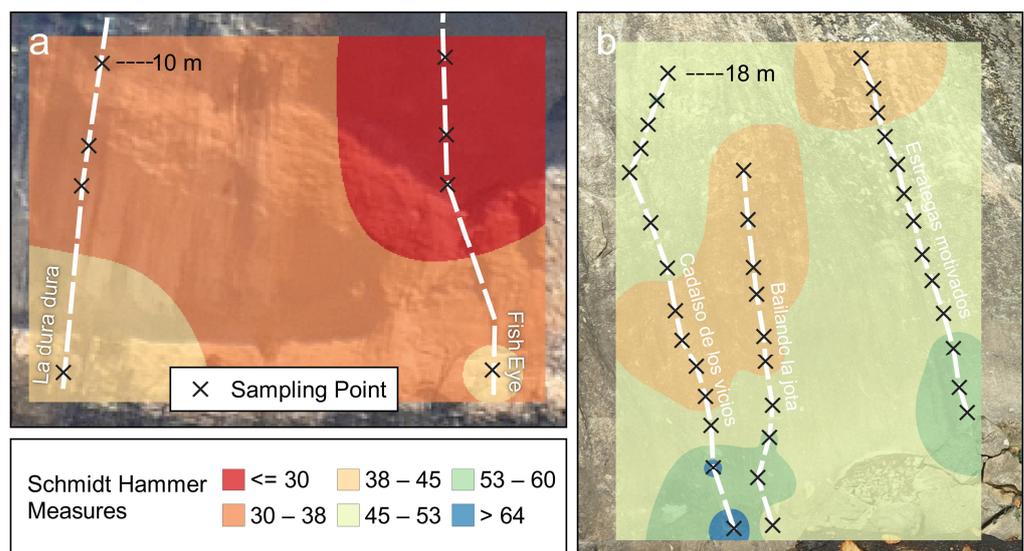
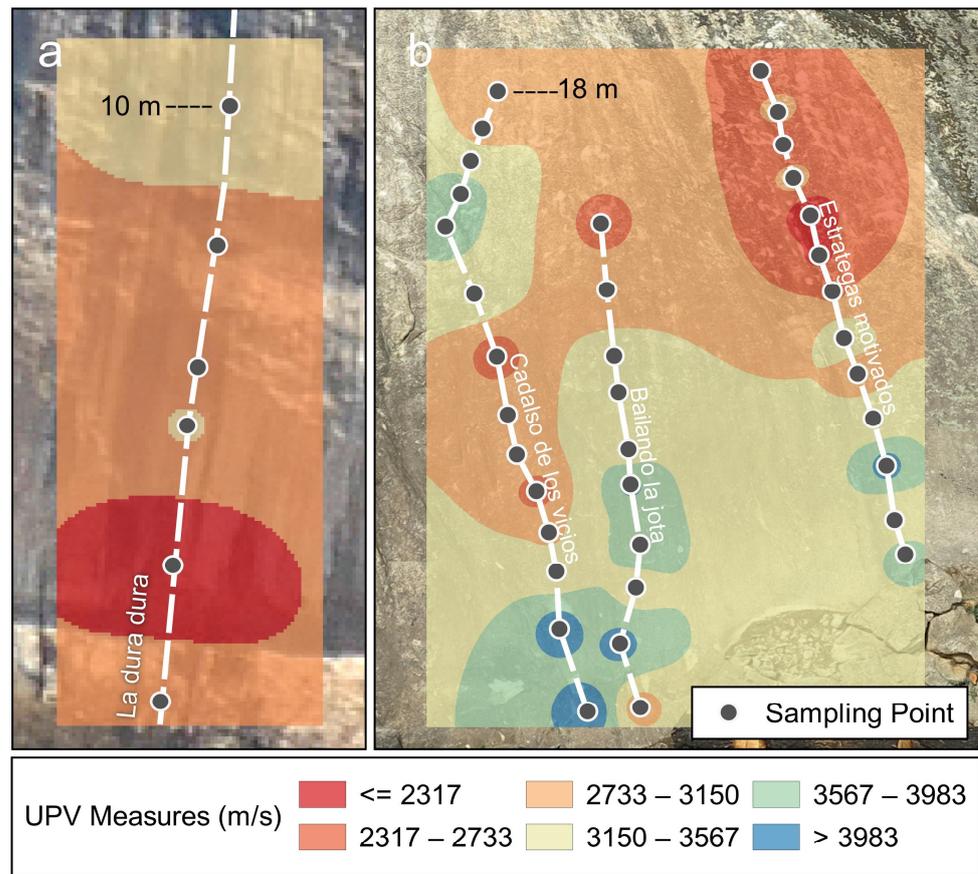
Figure 12. Spatial distribution of the SH measurements in: (a) “La Dura Dura” (Oliana) and (b) three routes in Site 6 of Cadalso de los Vidrios.

Figure 13. Spatial distribution of UPV measurements in: (a) “La Dura Dura” (Oliana) and (b) three routes in Site 6 of Cadalso de los Vidrios.

As referenced in the methodology, the iconic route of “La Dura Dura” in Oliana was selected for a detailed SH and UPV survey (Figures 12a and 13a). As this route was only partially affected by the fire, the results do not show the same large gradation as Cadalso. Figures 12b and 13b show SH and UPV maps from the three studied routes in Cadalso de los Vidrios and show a gradation of values: lower SH and UPV at the bottom, and lower SH and UPV to the top right. This gradation is coherent with the results obtained from the random grid measurements (Figure 11), in which the areas with detached spalling show higher SH and UPV values than those areas showing reddening. This is because reddened areas with non-detached spalling have more microcracks than those in which the surface affected by fire has detached and, therefore, a “new” surface not affected by the fire is exposed. The SH values differ slightly more than those of UPV and show less significant trends. This is because UPV values are influenced by a larger volume of rock than the SH rebound number, and are, therefore, less sensitive to minor and localized mineralogical heterogeneities of the rock.

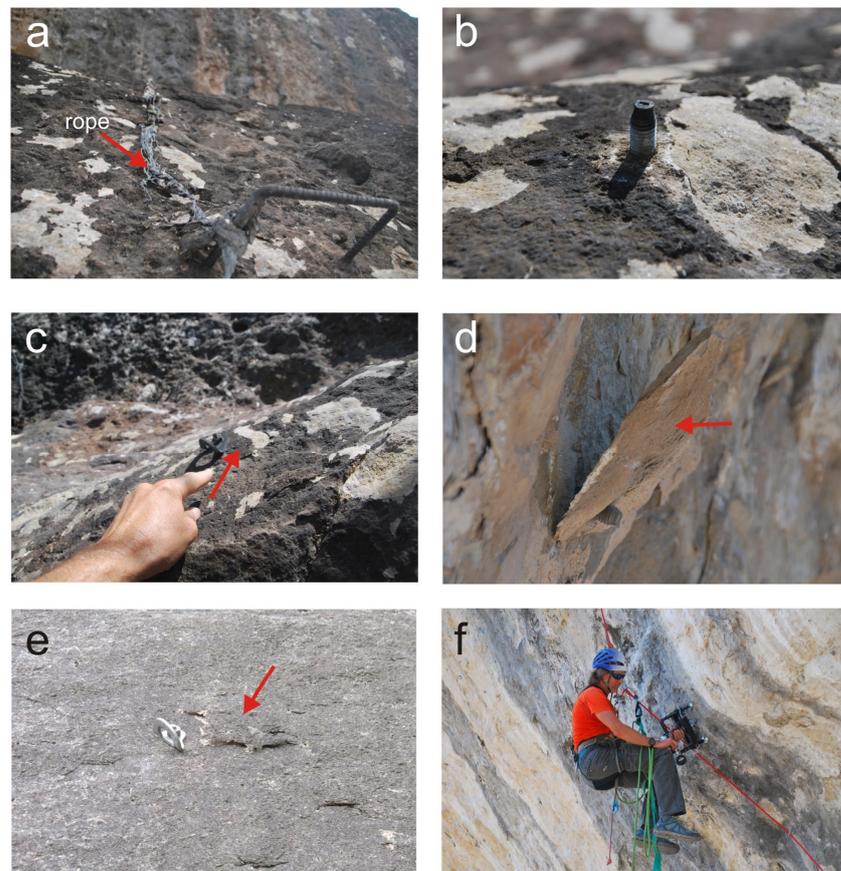
Figure 14. Impacts on climbing anchors: (a) remains of climbing ropes and iron stairs in Oliana; (b–d) spalling on anchors in Oliana; (e) exfoliation in Cadalso de los Vidrios near a bolt anchor; (f) anchor test in the “La Dura Dura” route.

The iconic climbing area of Oliana was affected in a different way. The left side of the wall has experienced dramatic changes by spalling, rockfalls, and shattering (Figure 7). All routes on the left side have been destroyed by fire, even up to the highest part (~40 m). The vertical hot currents caused a sudden thermal shock. Conversely, the central part of the wall—the place where the most iconic routes are located—was protected from the fire. The right side of the wall was also damaged (Figure 14a). Spalling not only affects the wall, but also several anchors lost a few centimeters of rock cover (Figure 14b–d). Surprisingly, the anchor test (Figure 14f) showed a good condition of all protections.
