Surface Mechanical Effects of Wildfires on Rocks in Climbing Areas

Pablo Yeste-Lizán ^{1,*}

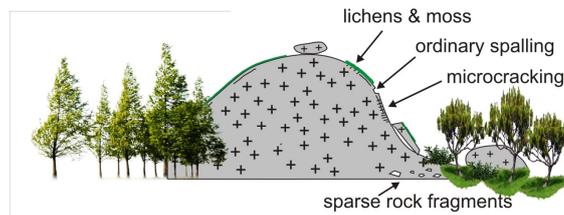
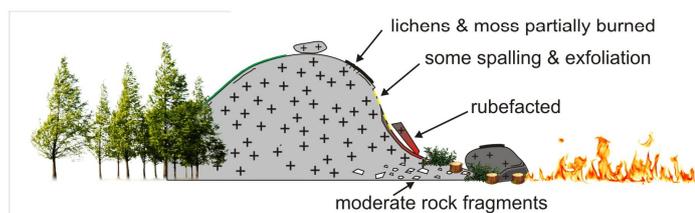
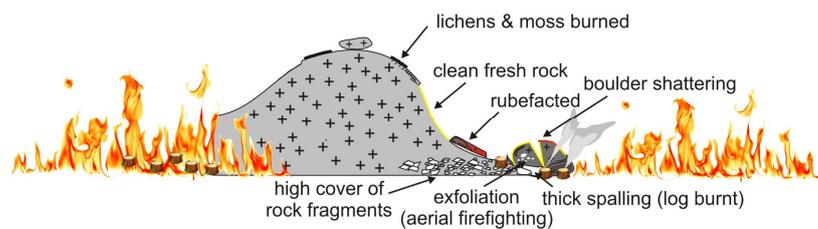
Wildfire weathering (Figure 15) has been noted as an important erosive agent, with changes in soil stoniness of up to 90% in the most damaged areas of Oliana. In Mediterranean areas, this effect has been demonstrated [46] by means of intense spalling. Both in Oliana and Cadalso, we noted the degree of spalling as a result of an increase in fire intensity and resulting sudden thermal shock. This effect is one of the most critical for sport climbing.

Figure 15. Surface mechanical effects of wildfires on rocks in the climbing areas: (a) ordinary situation with current weathering; (b) changes in bedrock by weak wildfire partially affecting an area; (c) strong effects of a wildfire on a bedrock wall.
